# FREE Studio Plus

## Release Notes

9MA10300.06

02/2023 v1.5.1

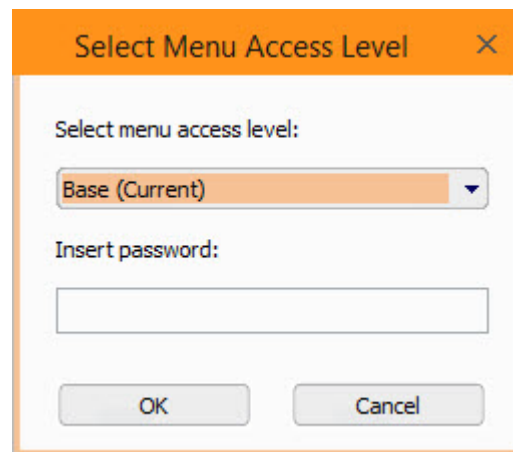
- Base
- Supervisor
- Admin

As soon as you have changed the Access level chosen will become (Current)

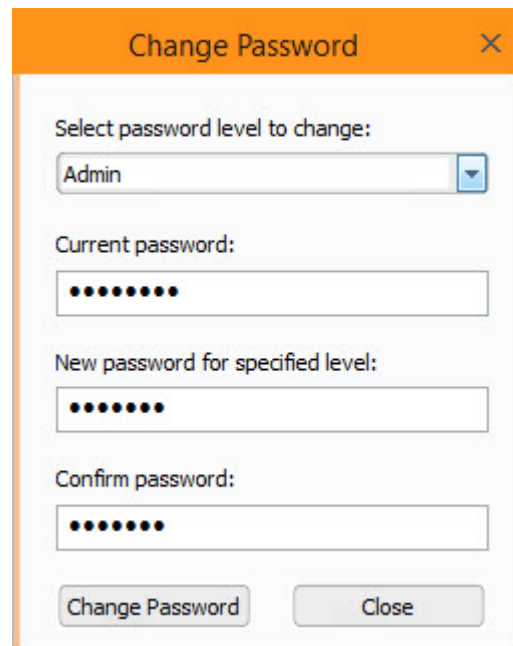
From the File menu change the Menu Access Level Password the first time you use it:

By default, the passwords are:

Base = no password  
 Supervisor = "service"  
 Admin = "administrator"
